Re: Notice of Violation
Omega Plating, Inc.
EPA ID No.: ILD 018 260 075

COMPLIANCE EVALUATION INSPECTION REPORT

INSTALLATION NAME: Omega Plating, Inc.
U.S. EPA ID No.: ILD 018 260 075
LOCATION ADDRESS: 4704 W. 137th Street
Crestwood, IL 60445
NAICS CODES: 332813 (Electroplating, Plating, Polishing,
Anodizing and Coloring)
DATE OF INSPECTION: September 6, 2013
EPA INSPECTOR: Michael Valentino

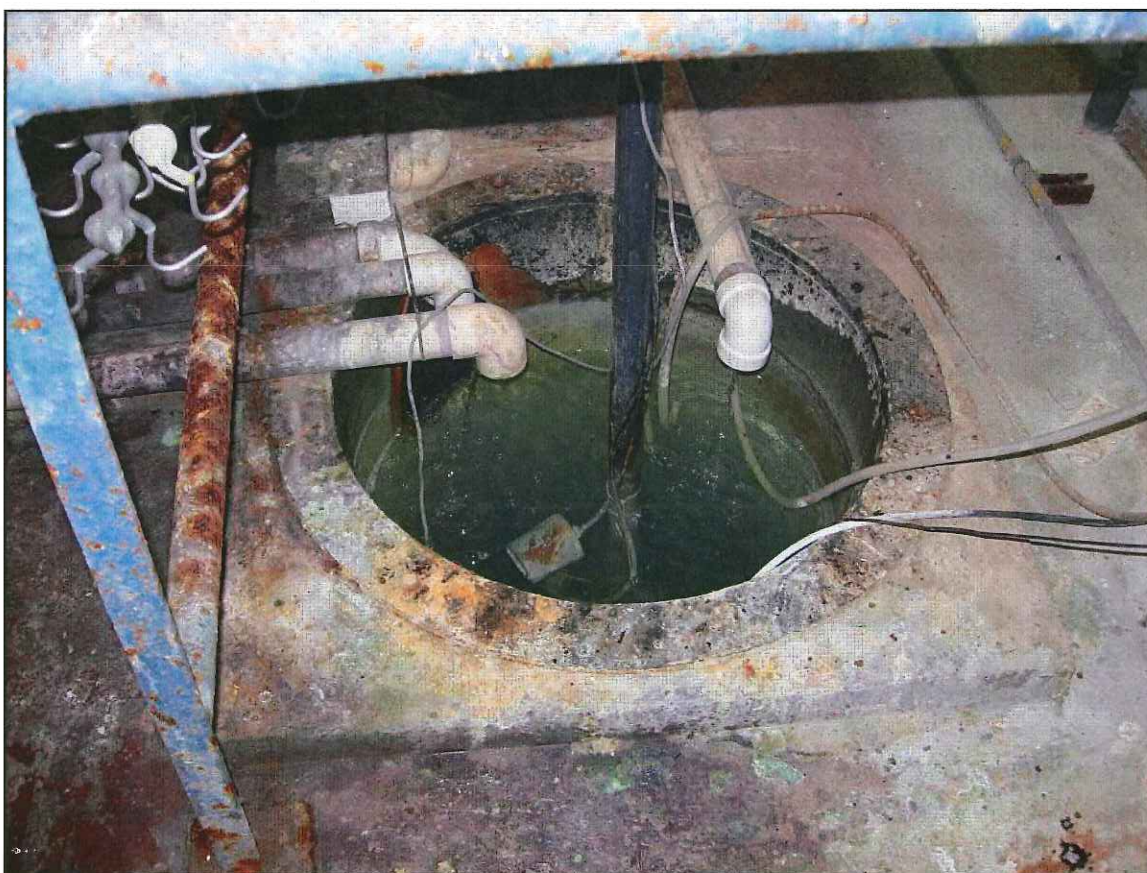
We began the site tour in the wastewater treatment area. There I observed a below grade pit where process wastewaters enter and are treated using HCl to destroy cyanide. (Photo 1.)

Photo 1 DSCN2576 2848 KB	Omega Plating, Inc. 4704 W. 137th Street Crestwood, IL 60445
9/6/13 9:59 am Taken by: Michael Valentino	<u>Description:</u> Wastewater treatment area. Sub-floor collection pit. Here the pH is adjusted to 9.0 and cyanide destruction with hypochlorite takes place.

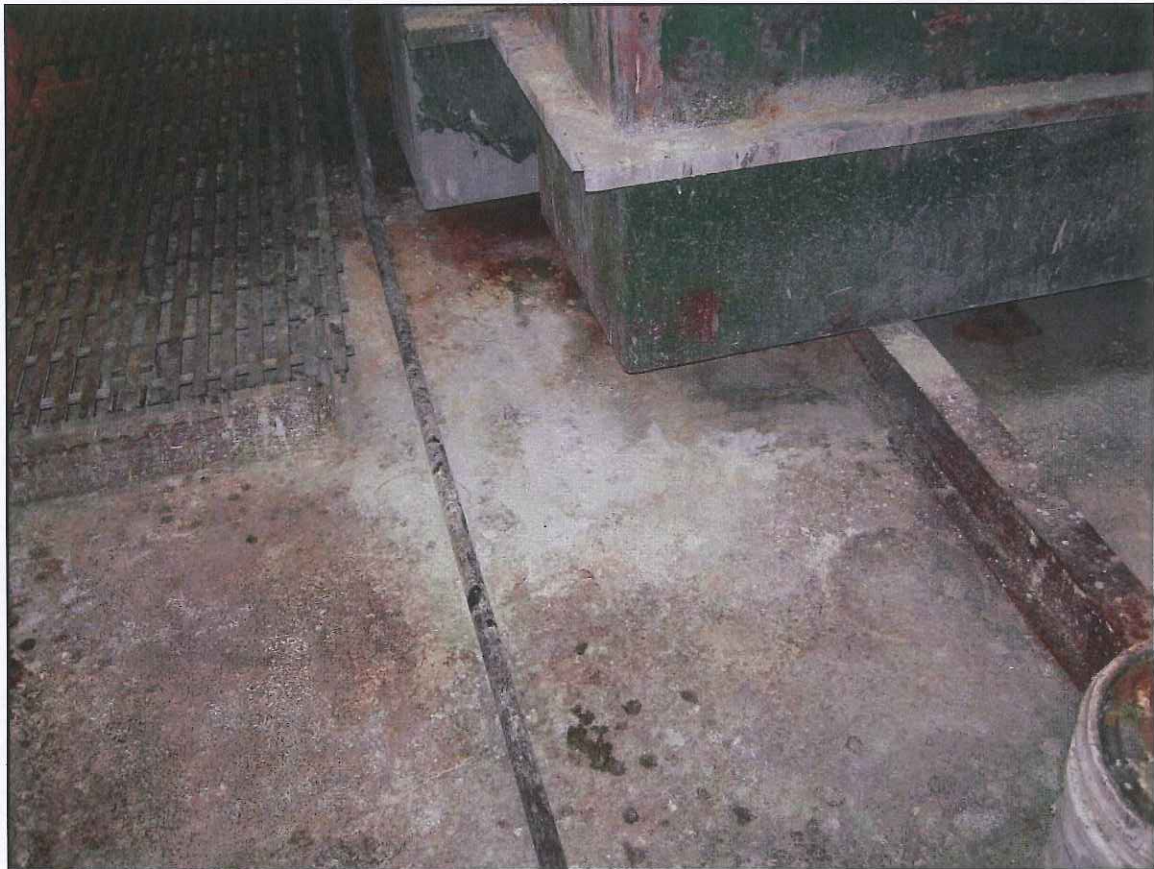
We then toured the plating area. Plating tanks are underlain with secondary containment consisting of steel berms and concrete containment and collection pits. (Photo 2.) I observed no standing liquids in the secondary containment on the day of the inspection.

Photo 2 DSCN2577 3391 KB	Omega Plating, Inc. 4704 W. 137th Street Crestwood, IL 60445
9/6/13 9:59 am Taken by: Michael Valentino	<u>Description:</u> Plating area. Floor condition beneath plating line.

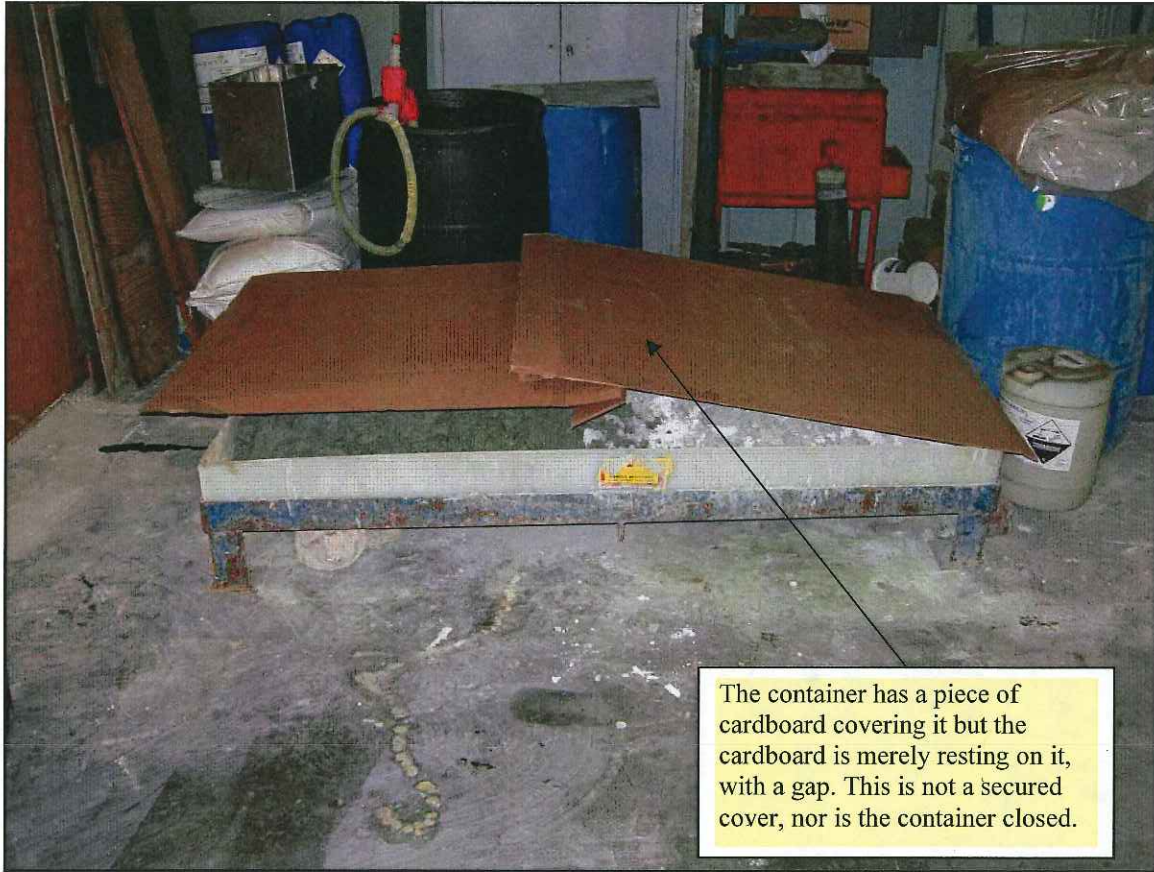
At the time of the September 6, 2013 inspection, the EPA inspector observed one open container which held filter press sludge (F006 waste). Said container was partially covered with a piece of cardboard and the cardboard, which served as a makeshift lid, was not secured.

A container situated directly beneath the filter press is used to transport filtered solids to one-cubic yard fabric bags for transferring filter press sludge to the designated facility. (Photo 5; also Photo 3.) One such transfer container was labeled and partially filled with filter cake (F006). (Photo 3.) Said container had a piece of cardboard covering it. Because spillage could still potentially occur, the container was not determined to be in a

closed condition. At the time of the inspection filter press sludge was not being added to the container, nor was it being removed into a fabric tote bag for offsite transport.

The container has a piece of cardboard covering it but the cardboard is merely resting on it, with a gap. This is not a secured cover, nor is the container closed.

Photo 3 DSCN2578 3834 KB	Omega Plating, Inc. 4704 W. 137th Street Crestwood, IL 60445
9/6/13 10:20 am Taken by: Michael Valentino	Description: Wastewater treatment area. Wastewater treatment sludge (carries waste code F006) container. Container has proper hazardous waste label. Container is covered with cardboard, but not closed.

Omega therefore failed to comply with the above-mentioned conditions for a hazardous waste storage permit exemption, and violated the hazardous waste container use and management requirement.

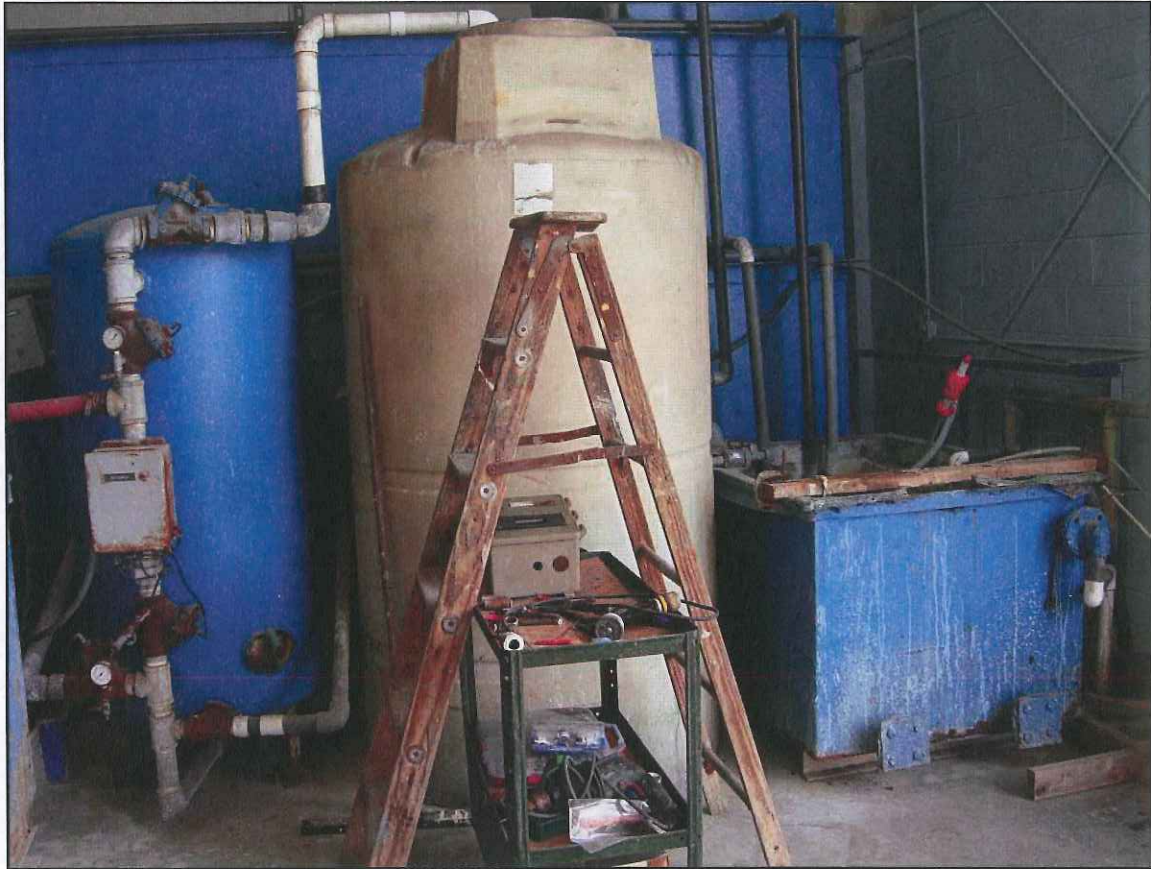
We continued touring the process wastewater treatment area. I observed a sand-filled vessel for final polishing (removal of particulate) and a tank in which effluent is adjusted to permitted pH limits. (Photo 4.)

Photo 4 DSCN2579 2604 KB	Omega Plating, Inc. 4704 W. 137th Street Crestwood, IL 60445
9/6/13 10:30 am Taken by: Michael Valentino	Description: Wastewater treatment area. Blue tank to left of photo is sand filter; white tank in center of photo is pH adjustment tank.

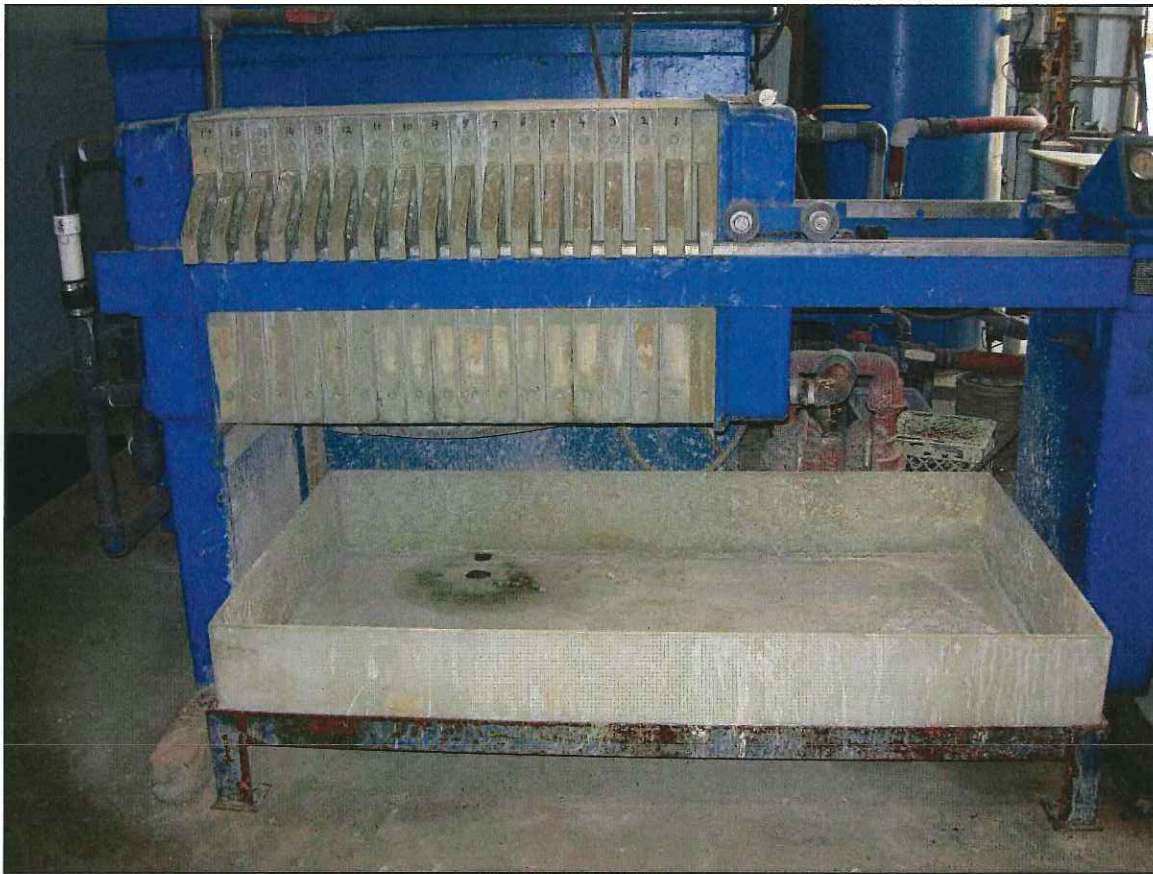
I observed a plate-and-frame filter press, which removes solids from treated process wastewaters. (Photo 5.) The filter press sludge is managed as a listed hazardous waste from a non-specific source (waste code F006).

We concluded the tour by observing the filter press. (Photo 5.)

Photo 5 DSCN2580 3536 KB	Omega Plating, Inc. 4704 W. 137th Street Crestwood, IL 60445
9/6/13 10:31 am Taken by: Michael Valentino	<u>Description:</u> Wastewater treatment area. Plate-and-frame filter press. Empty wastewater treatment sludge container rests beneath the filter press.
